# **EREDINE WIND FARM FURTHER ENVIRONMENTAL INFORMATION**

CONFIDENTIAL - Technical Appendix 6A: Otter  
Survey Baseline Report 2025

**PROJECT NO. UK0041761.4562**

**DATE: SEPTEMBER 2025**

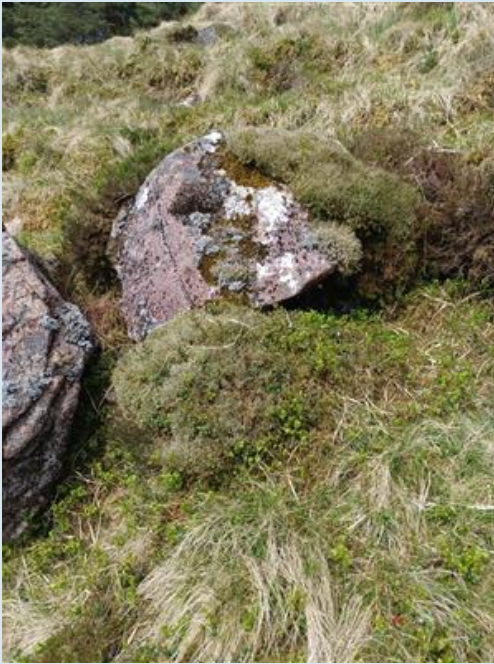
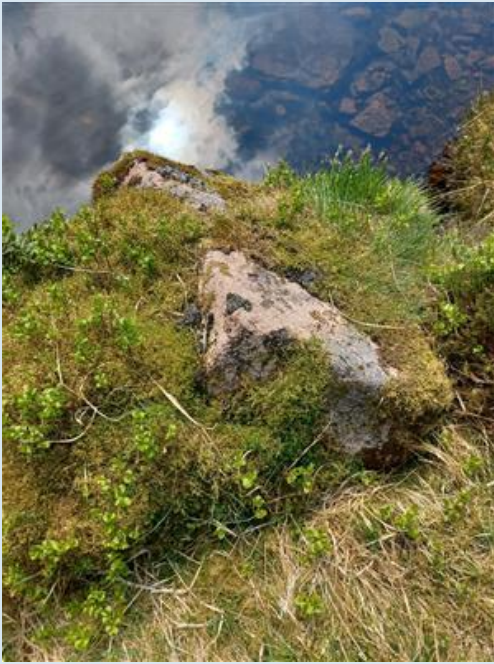
- A single confirmed otter resting site was identified (TN1) on the banks of a small unnamed waterbody, [REDACTED]. This resting site is within a boulder pile, on the north bank of the water body, with an otter latrine present. The resting site was considered shallow and unlikely to be large enough to support more than an individual otter. However, there was clear signs of use by a mammal, due to the paths leading into this feature. Both otter spraint and fox scat were found surrounding this resting site.

| TN | Feature | Description | 2025 Result | 2025 Image | |
|---|---|---|---|---|---|
| TN1 | Confirmed Resting Site | Resting site beneath boulder on bank of unnamed waterbody with otter latrine (>5 otter spraints within 2m of resting site). Tracks present from water to resting site entrance with the internal cavity not considered suitable to support more than individual otters at each time. | Otter spraints both dry and wet present at nearby latrine as well as mammal path leading to the resting site entrance. Fox scat (including fresh scat) present nearby resting site and latrine. | | |

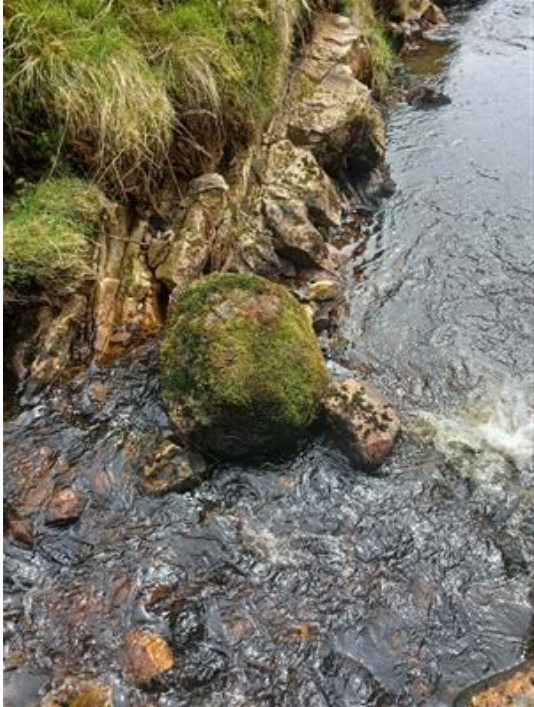
- Another confirmed couch was recorded at TN2, [REDACTED]. It was recorded as a potential couch during the 2020 surveys, however, spraints were recorded within 1m of this feature during the 2025 surveys and so was confirmed as an otter resting site. No further confirmed otter resting sites were identified.

| TN | Feature | Description | 2025 Result | 2025 Image |
|---|---|---|---|---|
| TN2 | Confirmed couch | Sheltered undercut banking. No otter field signs observed within banking but otter spraints within 1m of this feature. | Bank erosion since 2020 surveys has removed depth of cover leaving partial cover of undercut banking. Otter spraints found on rocks instream of cover, less than 1m from this point. | |
